# PROPERTY CONDITION REPORT

Feb 12, 2026

# KEY DEFECTS IDENTIFIED

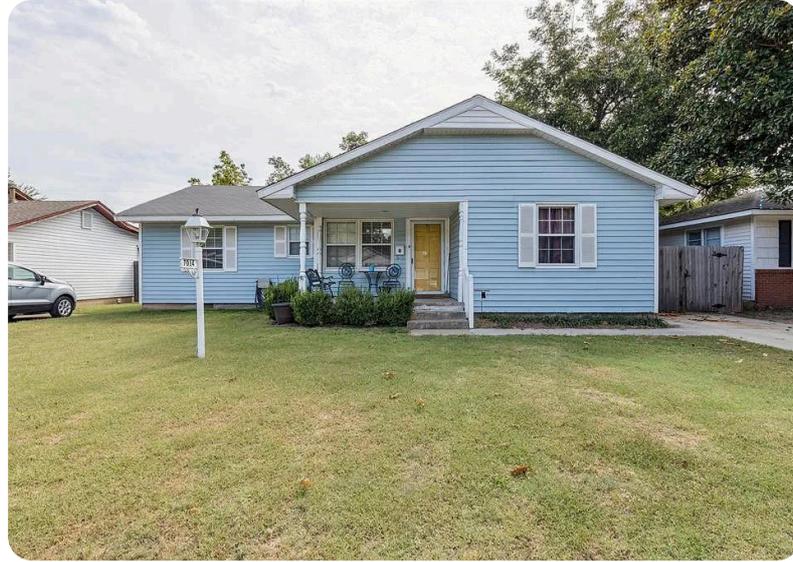
### Exterior: Gutters Missing

Shrubbery in front of the porch is growing in direct contact with the structure. The grading around the front of the home appears relatively flat, with little or no slope away from the foundation. Gutters are missing from the home, and roof runoff does not appear to be directed away from the structure.

Vegetation in contact with the structure can trap moisture against siding and foundation materials, promote rot and deterioration, and provide pathways for insects and pests. Flat grading does not direct surface water away from the building and increases the risk of water pooling near the foundation, which may contribute to basement or crawlspace moisture intrusion and long-term structural settlement. The absence of gutters allows roof runoff to discharge directly at the foundation, significantly increasing soil saturation, erosion, and the likelihood of moisture intrusion into lower-level spaces.

Shrubbery should be trimmed back or relocated to maintain adequate clearance from the structure. A qualified contractor or landscaper should regrade the soil to create a positive slope away from the foundation in accordance with International Residential Code Section R401.3. A licensed contractor should install a complete gutter and downspout system to collect and discharge roof runoff, with downspout extensions directing water several feet away from the foundation.

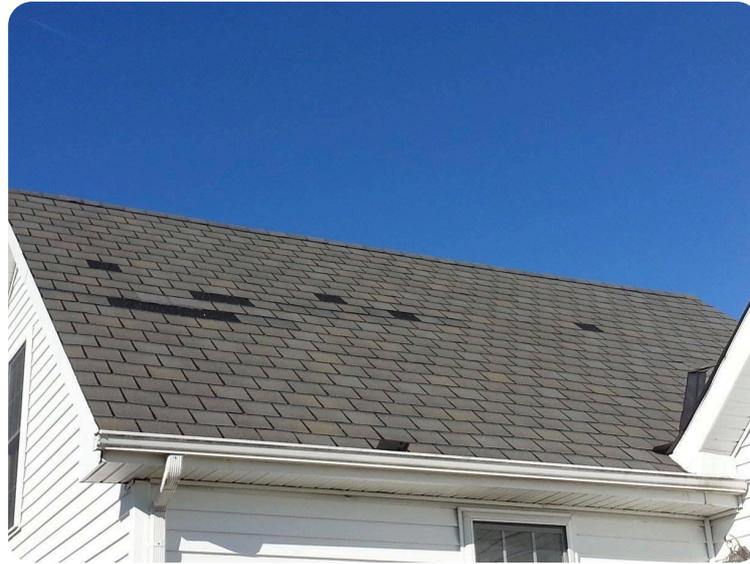
### **Roof: Missing Shingles**

Several shingles are missing from the roof surface. The underlying shingle courses and portions of the roof covering are exposed to the weather in the affected areas.

Missing shingles reduce the roof's ability to shed water and significantly increase the likelihood of leaks, water intrusion, and damage to roof decking, attic insulation, and interior finishes. Exposed areas are more vulnerable to wind uplift and further shingle loss, which may accelerate deterioration of the roof covering.

A licensed roofing contractor should evaluate the roof and replace the missing shingles as soon as possible. The contractor should also inspect surrounding shingles and flashing for looseness or damage, and verify whether concealed moisture damage is present beneath the affected areas. If missing shingles are widespread or associated with age-related deterioration, partial or full roof replacement may be recommended.

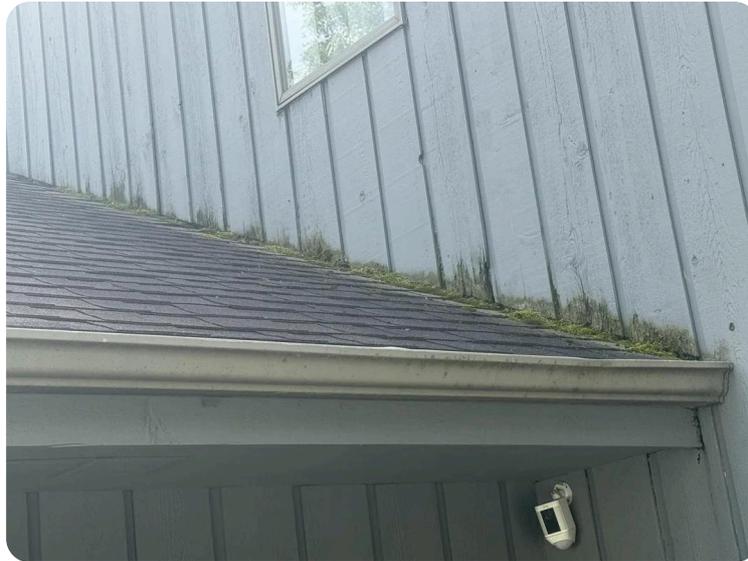
## Exterior: Missing Kickout Flashing and Improper Siding Clearance

No kickout flashing is visible at the eave-to-wall intersection. The vertical siding is in direct contact with the roof shingles. Moss and organic growth are present along the roof-to-wall intersection. Dark staining and discoloration are visible on the bottom edges of the siding panels. Vegetation is in contact with the structure.

Missing kickout flashing can allow water to run down the exterior wall, potentially causing concealed water damage. Siding in direct contact with the roof can wick moisture, potentially leading to rot and decay. Moss accumulation can trap moisture, potentially accelerating material deterioration. Moisture damage to siding can indicate water saturation, potentially leading to structural compromise. Vegetation contact can retain moisture, potentially increasing the risk of decay.

Have a qualified contractor install kickout flashing to direct water into the gutter. Consult a professional to adjust the siding clearance to meet the requirements of IRC R703.8.6.1. Engage a licensed contractor to remove moss and organic growth to prevent moisture retention. Assess the siding for moisture damage and replace affected areas as needed. Trim vegetation away from the structure to prevent moisture contact.

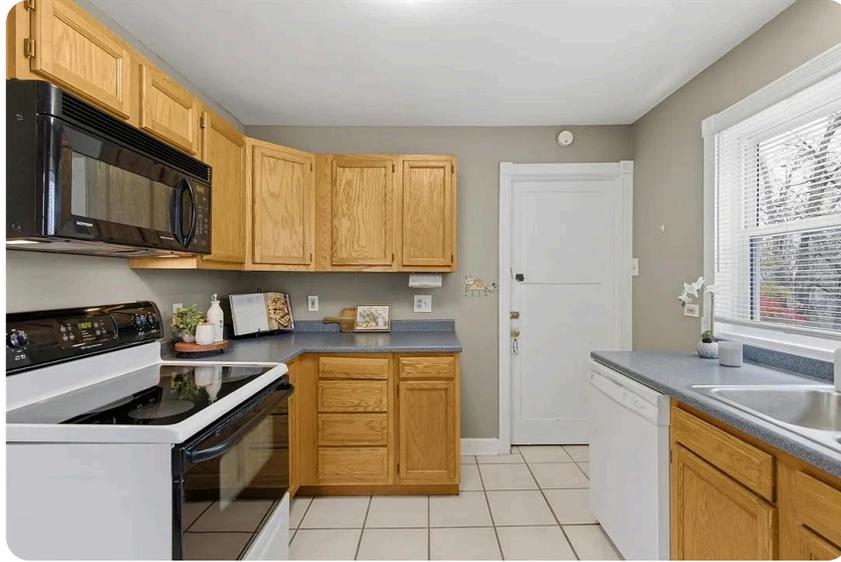
### **Kitchen: Lack of Outlets**

Insufficient outlet coverage in a kitchen work area can lead to the frequent use of extension cords or power strips, which increases the risk of electrical overheating, shock, or fire. Modern safety standards require readily accessible outlets in countertop areas, particularly near sinks where portable appliances are commonly used. The absence of properly located outlets also means Ground-Fault Circuit-Interrupter protection may be lacking in a moisture-prone environment.

Install new Ground-Fault Circuit-Interrupter-protected countertop outlet(s): \$200–\$500 per outlet.

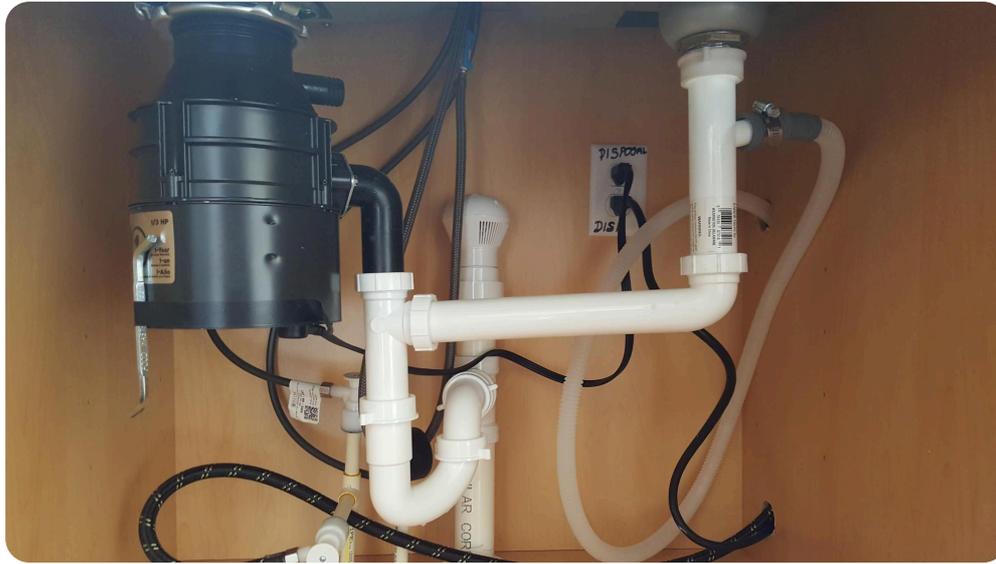
*GFCI protection for this outlet may be provided upstream of the outlet but is not observable from the photo.*

## Kitchen: Dishwasher High Loop Missing, GFCI Protection Not Observed

The dishwasher drain installation is missing a “high loop.” The drain hose does not rise and loop upward beneath the countertop before connecting to the disposal or sink drain. In addition, the electrical outlet located under the sink does not appear to be Ground-Fault Circuit-Interrupter protected.

Without a high loop, wastewater from the sink or disposal can backflow into the dishwasher drain line, allowing contaminated water and debris to enter the appliance. This can lead to odors, unsanitary conditions, and potential bacterial contamination of dishware. A non-Ground-Fault Circuit-Interrupter-protected outlet located under a sink is exposed to a moisture-prone environment, increasing the risk of electrical shock and not meeting modern electrical safety standards.

A licensed plumber or qualified appliance installer should correct the dishwasher drain routing by installing a proper high loop beneath the countertop or an air gap device where required by local code or manufacturer instructions. A licensed electrician should replace the under-sink receptacle with a Ground-Fault Circuit-Interrupter-protected outlet or provide Ground-Fault Circuit-Interrupter protection at the circuit in accordance with the National Electrical Code.

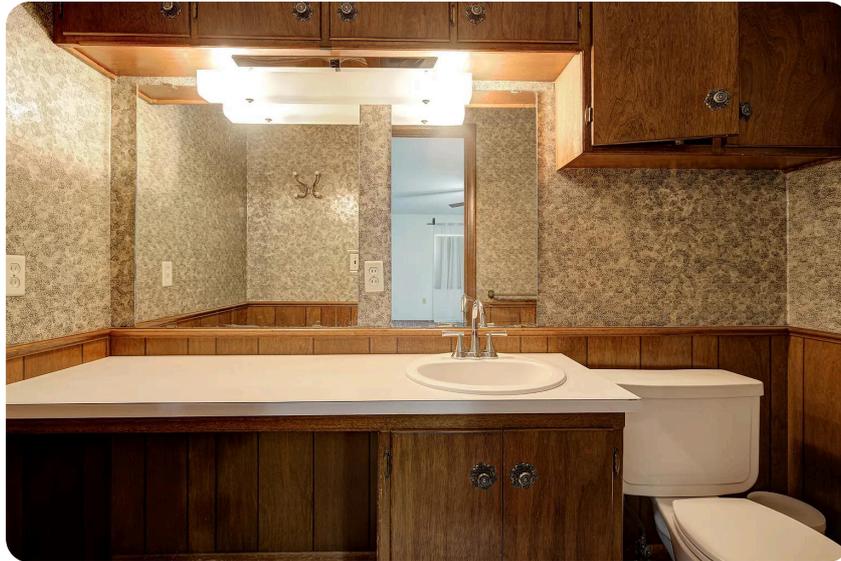
## Bathroom: Two-Prong Outlet, Toilet Clearance Issue

An ungrounded, non-Ground-Fault Circuit-Interrupter-protected outlet in a bathroom increases the risk of electrical shock in a moisture-prone environment and does not meet modern electrical safety standards. Insufficient toilet side clearance can reduce usability and occupant comfort, may not comply with plumbing clearance requirements, and can complicate future fixture servicing or replacement.

A licensed electrician should evaluate the bathroom circuit and either replace the existing two-prong outlet with a properly grounded receptacle where a grounding conductor is present, or install Ground-Fault Circuit-Interrupter protection with required labeling in accordance with National Electrical Code Section 406.4(D) and Ground-Fault Circuit-Interrupter protection requirements for bathrooms. A qualified contractor or plumber should verify the toilet clearance and modify the toilet location, cabinet, or wall configuration as needed to achieve at least 15 inches of side clearance from the centerline of the toilet in accordance with International Residential Code plumbing clearance provisions.

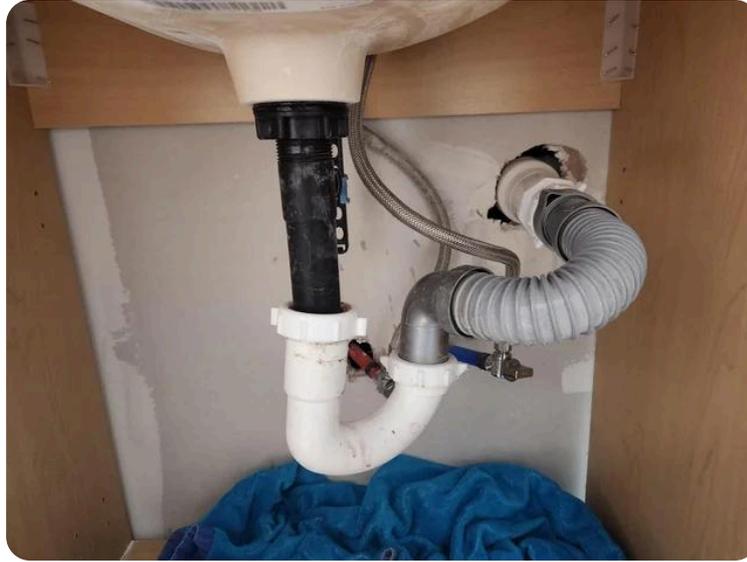
### **Bathroom: Flexible Drain Line, Poor Slope, Colored PEX**

A flexible accordion-style drain line is installed under the sink. The drain piping exhibits a negative slope, causing portions of the line to drain “uphill,” which impedes proper flow. Evidence of an active or recent leak is present, as indicated by a towel placed beneath the P-trap. Colored PEX water supply lines are present; some legacy PEX products from certain manufacturers have been subject to past performance concerns or litigation. The flexible drain pipe is prone to clogging, trapping debris, and leaking.

Accordion-style flexible drain piping creates turbulence and debris accumulation, increasing the likelihood of clogs and leaks and does not meet best-practice plumbing installation standards. Negative drain slope prevents proper gravity drainage, allowing wastewater to sit in the pipe, which can lead to odors, bacterial growth, and recurring leaks. Evidence of leakage indicates an active moisture condition that may damage cabinetry, finishes, and concealed materials and may promote mold growth. Questionable or defective PEX products could pose a long-term risk of supply line failure if not verified and addressed.

A licensed plumber should remove the accordion-style flexible drain and install a rigid, properly configured drain assembly with a code-compliant P-trap and a correctly sloped trap arm to ensure continuous downward drainage. All fittings and joints should be sealed and supported to prevent movement and recurrence of leaks. The plumber should also evaluate the colored PEX supply lines to verify manufacturer type and lot history and recommend replacement if the product is known to be defective or recalled. Cabinet and surrounding materials should be inspected for moisture damage and dried or repaired as needed.

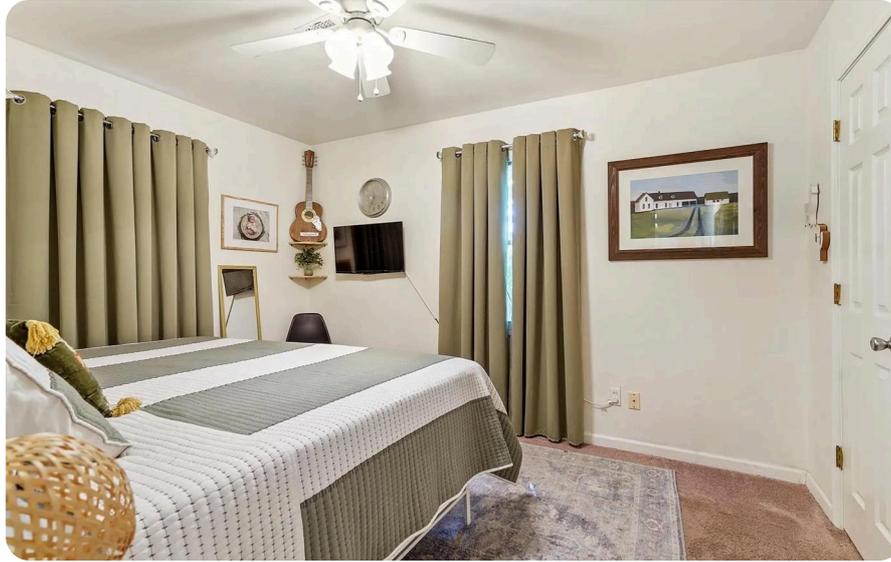
## Two-Prong Outlet Observed

Ungrounded outlets provide no equipment grounding path for modern electronics or appliances, which increases the risk of electrical shock and potential equipment damage. These outlets do not meet modern safety expectations and may indicate aging branch-circuit wiring that warrants further evaluation.

A licensed electrician should evaluate the circuit. Where an equipment grounding conductor is present, the outlet should be replaced with a grounded three-prong receptacle in accordance with National Electrical Code Section 406.4(D)(1). Where no grounding conductor is present, correction should be made in accordance with National Electrical Code Section 406.4(D)(2), which permits installation of Ground-Fault Circuit-Interrupter protection with required “No Equipment Ground” labeling or rewiring the circuit to provide proper grounding.

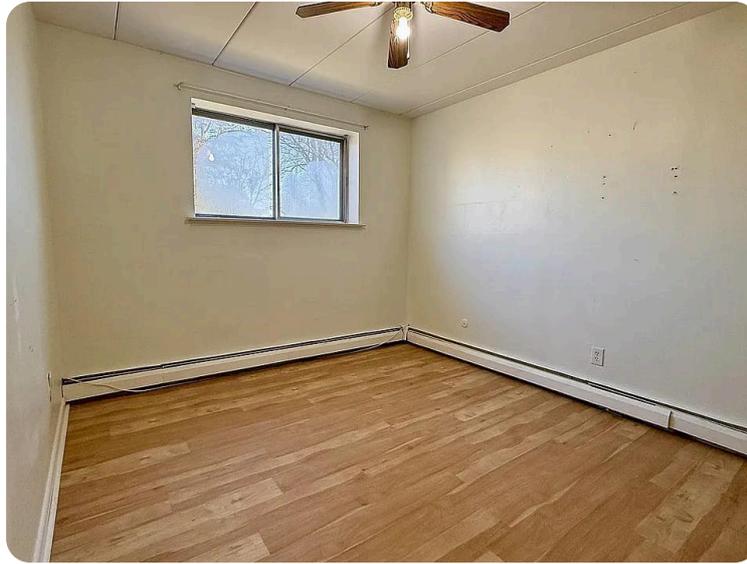
### **Bedroom: Egress Window & Lack Of Outlets**

A missing electrical outlet is present on the window wall. An outlet is installed above the electric baseboard heater. The bedroom window appears too small for the required net clear opening for emergency escape. The window sill height appears to exceed the maximum 44 inches from the floor. The right wall exhibits multiple scuffs, marks, and small holes.

A missing electrical outlet on the window wall may not comply with NEC 210.52(A), potentially limiting electrical access and convenience. An outlet above the baseboard heater can lead to overheating of cords, increasing the risk of fire hazards. A window that is too small for emergency escape can hinder egress during emergencies, potentially compromising occupant safety. A window sill height exceeding 44 inches can make emergency egress difficult, increasing the risk of injury. Cosmetic wall damage does not pose a safety risk but may affect aesthetic appeal.

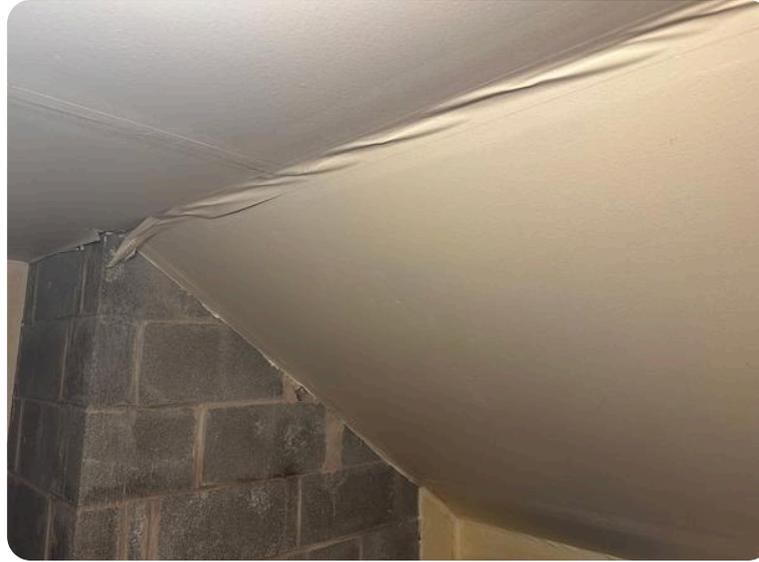
## Interior: Drywall Separation

The ceiling surface shows significant deformation and separation along the sloped ceiling-to-wall joint. The drywall or plaster finish is buckled and appears to be pulling away from the substrate, with visible ridging and material displacement along the joint line. This condition is occurring adjacent to a masonry block chimney or wall surface.

Ceiling deformation of this type is commonly associated with moisture intrusion, structural movement, or failure of drywall fasteners and tape joints. If moisture is present from roof leakage, chimney flashing failure, or condensation at the masonry surface, continued deterioration and potential mold growth may occur behind the finish surface. If structural movement or settlement is contributing, further cracking, separation, or localized ceiling collapse may result. The condition suggests that concealed materials may already be damaged.

A qualified contractor should remove a limited portion of the damaged ceiling material to evaluate the condition of the underlying framing, fasteners, and insulation, and to check for moisture intrusion or flashing leaks at the chimney intersection. If moisture is confirmed, the source should be identified and repaired prior to any interior repairs. If structural movement or framing distress is suspected, consultation with a licensed structural engineer is recommended. After the underlying cause is corrected, damaged drywall or plaster should be replaced and the finish restored.

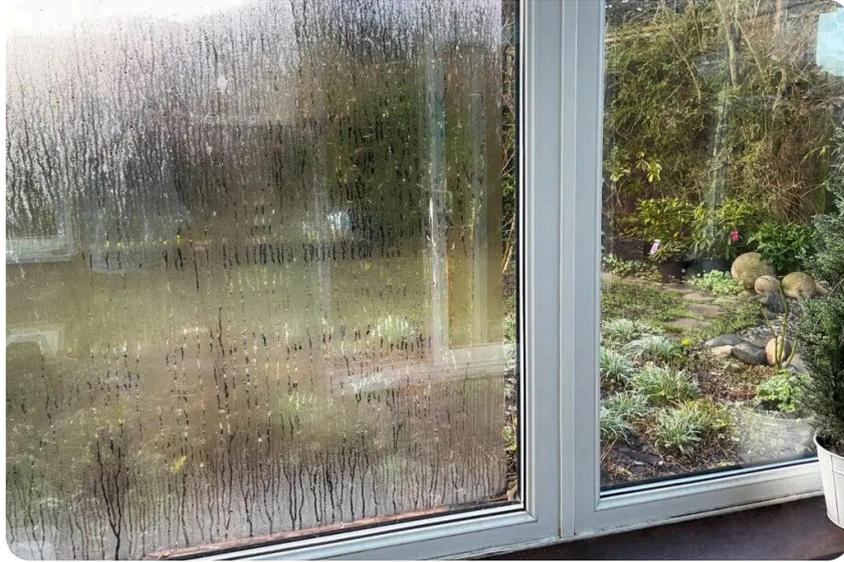
## Living Room: Window Seal Failure with Moisture Intrusion and Staining

The left window pane exhibits extensive fogging. Condensation droplets are present on the left window pane. Dark vertical streaks are visible on the left window pane. The thermal seal of the left window pane has failed. Moisture intrusion is evident between the glass layers of the left window pane. Dark discoloration is visible along the bottom edge of the left window pane.

A failed thermal seal can allow moisture intrusion, potentially leading to further deterioration of the window components. Moisture accumulation between glass layers can obscure visibility and reduce energy efficiency. Dark staining may indicate prolonged moisture exposure, potentially leading to mold growth or structural damage.

Have a qualified window contractor replace the window pane or window as necessary.

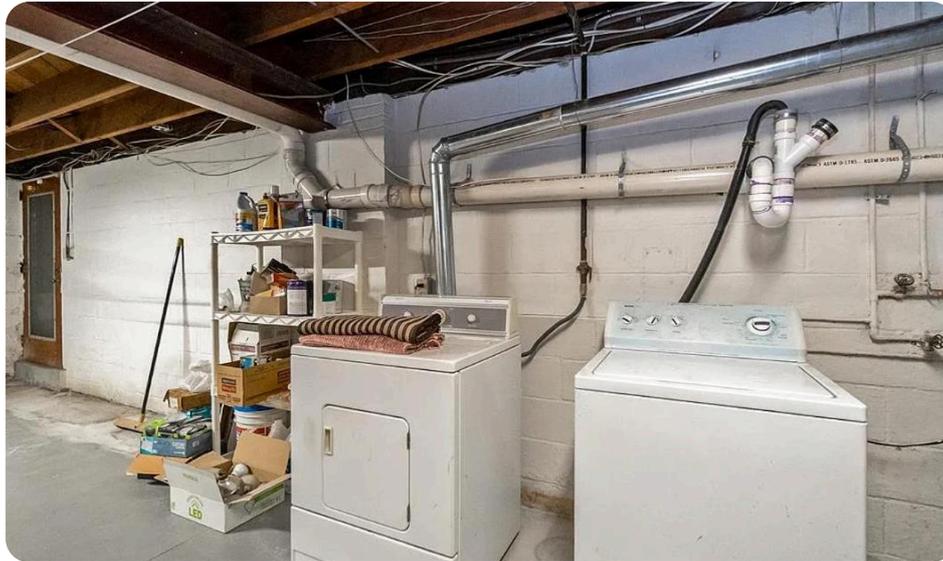
## Laundry: Standpipe Location Poor

Improper trap height and proximity to the standpipe can result in poor drainage or overflow, siphoning, or overflow during appliance discharge, and may reduce trap seal effectiveness, increasing the risk of sewer gas entering the living space.

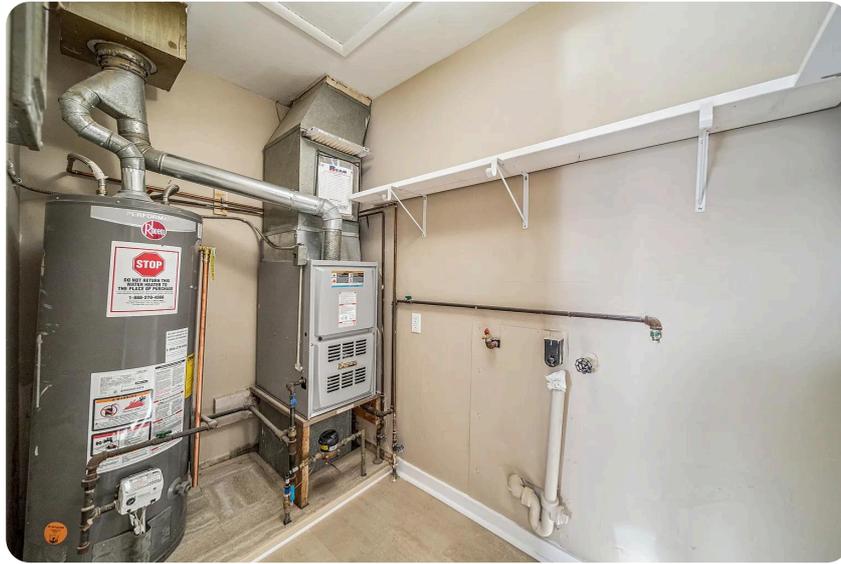
## Laundry: Missing GFCI, Drain Pan Missing, No Expansion tank

The laundry receptacle is not GFCI-protected. The water heater is installed without a drain pan beneath it, which could allow leakage to damage the surrounding floor area. The condensate drain line for the furnace is not visible and may be missing, concealed, or improperly connected. The water heater is missing an expansion tank.

Lack of GFCI protection in the laundry area increases the risk of electrical shock in a moisture-prone environment, and does not comply with modern electrical safety requirements (National Electrical Code Section 210.8(A)). A missing water-heater drain pan increases the likelihood of water damage to flooring and adjacent materials if leakage or tank failure occurs. A missing or improperly routed furnace condensate drain can result in hidden moisture damage, mold growth, corrosion, or equipment malfunction. A missing expansion tank could lead to undue stress on the plumbing system.

Have a licensed electrician install GFCI protection for the laundry receptacle in accordance with NEC 210.8(A). Have a licensed plumber install an approved drain pan and drain line (where required) below the water heater to help prevent leak-related damage. A licensed HVAC technician should verify the presence and routing of the furnace condensate drain line and install or correct the drain and termination as needed. Have a licensed plumber install an expansion tank.

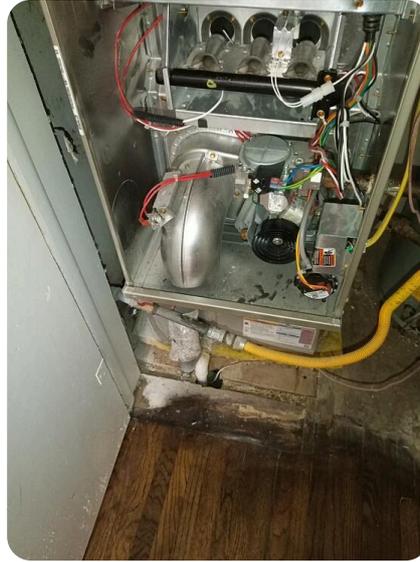
## Furnace: Exhaust Vent Missing

The furnace is a natural gas furnace. The draft inducer motor is not connected to an exhaust vent and is oriented downward rather than upward. The flue gases do not appear to be properly routed into a vent connector or chimney system. The natural gas line is missing a debris trap.

A disconnected or improperly oriented draft inducer presents a serious life-safety hazard. Combustion gases — including carbon monoxide — may be discharged directly into the indoor space instead of being vented outdoors. This condition can result in elevated carbon monoxide levels, oxygen depletion, and severe health or fatal exposure risks. The furnace may also operate outside of manufacturer design parameters, increasing the risk of overheating and equipment failure. A missing debris trap in the gas line can lead to damage for the gas-burner assembly.

The furnace should not be operated until corrected. A licensed HVAC technician should immediately evaluate the furnace venting system, reconnect the draft inducer to a properly sized and configured vent connector, and ensure the complete venting system complies with the manufacturer's installation instructions and International Residential Code venting provisions (G2427) and install a debris trap for the gas line. After repairs, the system should be tested for proper draft and carbon monoxide discharge using appropriate combustion analysis equipment.

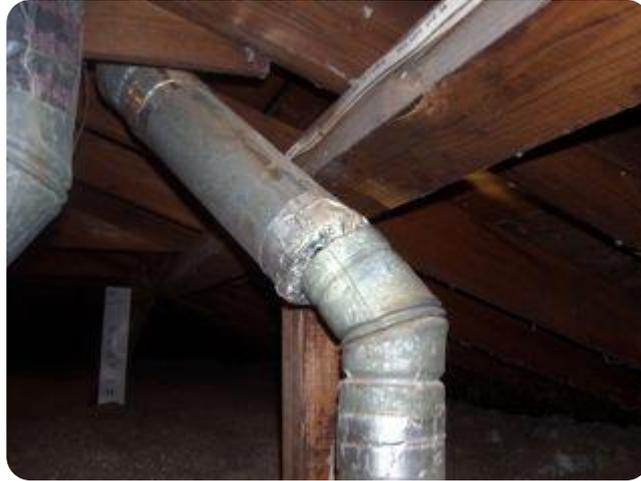
### Furnace: Exhaust Vent Connection Poor

The furnace exhaust vent appears to be poorly connected or improperly secured. Visible gaps, misalignment, or loose joints are present in the vent connector serving the furnace exhaust system.

An improperly connected furnace exhaust vent may allow combustion gases — including carbon monoxide — to leak into the interior of the home instead of being safely discharged outdoors. This presents a serious life-safety hazard and may also result in poor furnace draft, incomplete combustion, soot accumulation, and equipment damage. Improper vent connections typically do not comply with manufacturer installation requirements or applicable mechanical code provisions.

The furnace should be evaluated promptly by a licensed HVAC technician. The vent connector should be properly re-secured, resealed, or replaced as necessary to create continuous, positively sloped, mechanically fastened joints in accordance with the manufacturer's installation instructions and International Residential Code venting requirements (G2427). After corrections are completed, the technician should verify proper draft and check for carbon monoxide leakage during operation.

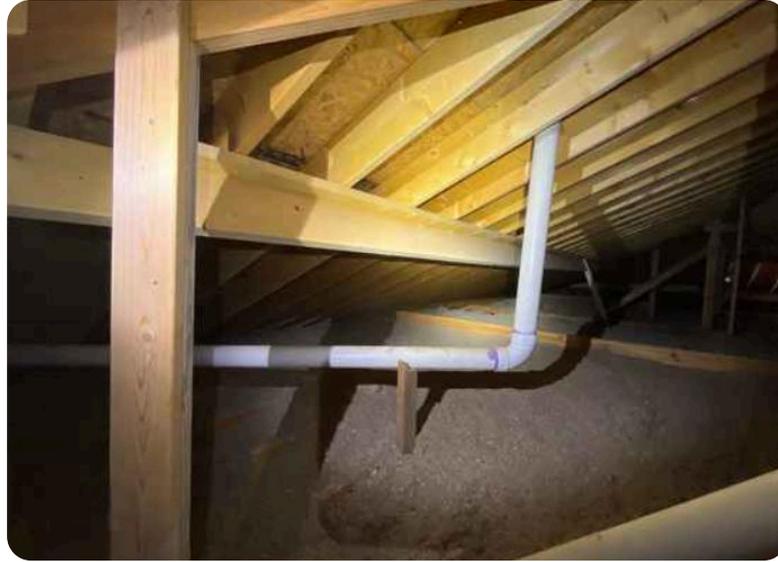
### **Attic: Purlin Bracing Inadequate, PVC Pipe Not Supported**

Purlin bracing supporting the roof rafters is inadequate. Bracing is not installed at the required intervals. The International Residential Code Section R802.4.5 requires purlin braces to be installed at a spacing not greater than 4 feet on center, and the current configuration does not appear to meet this requirement. A horizontal PVC vent pipe is present in the attic. The pipe is supported by a makeshift wooden prop. Proper pipe hangers or straps are not used.

Inadequate purlin bracing can reduce the roof system's ability to resist downward and lateral loads. This may result in rafter deflection, roof sagging, cracking of interior finishes, and potential structural deformation under snow or wind loads. Prolonged structural stress may worsen over time and increase the risk of localized structural failure. Improper pipe support can lead to instability, potentially causing pipe movement or disconnection.

A qualified framing contractor should evaluate the roof framing and install additional purlin braces to comply with International Residential Code Section R802.4.5, ensuring braces are properly sized, aligned, and spaced at no more than 4 feet on center with load paths terminating at bearing walls or other structural members. If structural distortion or sagging is already present, consultation with a licensed structural engineer is recommended prior to repairs. Have a qualified plumber install proper pipe hangers or straps to secure the PVC vent pipe to the framing

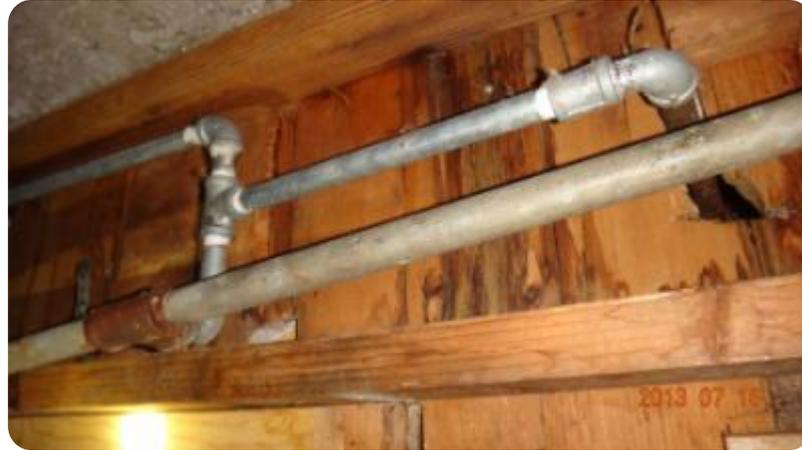
## Basement: Galvanized Steel Water Supply Lines and Corrosion Detected

Galvanized steel water supply lines are present. Corrosion is visible on pipe fittings. Rust and oxidation are present at threaded connections. Water staining is visible on wood near plumbing pipes.

Galvanized steel water supply lines can corrode internally, potentially restricting water flow and leading to leaks. Corrosion on pipe fittings can weaken connections, increasing the risk of water leaks. Water staining on wood may indicate past or present leaks, potentially leading to structural damage or mold growth.

Have a licensed plumber replace galvanized steel water supply lines with modern materials to prevent leaks and ensure adequate water flow. Consult a qualified plumber to assess and replace corroded pipe fittings to prevent potential leaks. Recommend verifying the source of water staining by a qualified contractor to address any underlying leaks and prevent further damage.

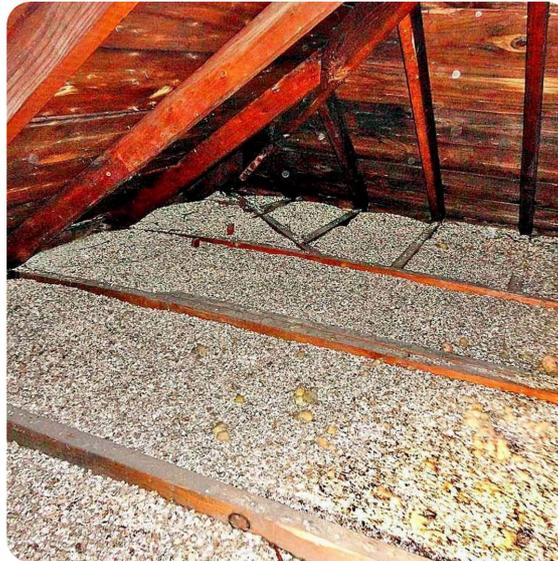
*We strongly caution buyers and recommend professional consultation before proceeding with purchase.*

## Attic: Vermiculite Insulation Present

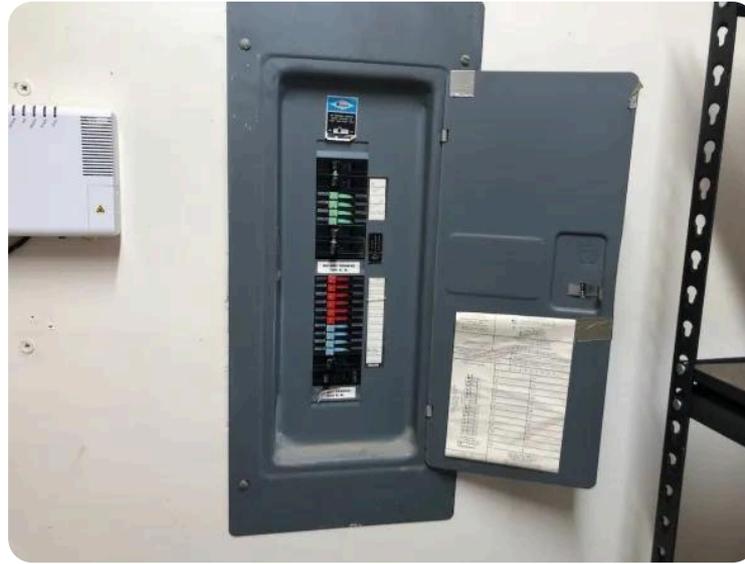
Known panel failure risks create elevated fire hazard and warrant replacement.

## Zinsco Electrical Panel: Dangerous and Lacking AFCI/GFCI Protection

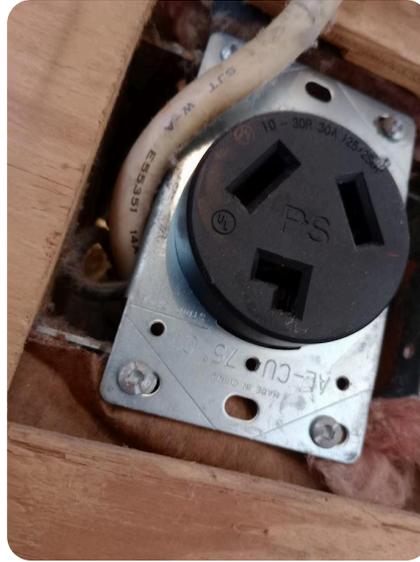
Exposed and potentially undersized wiring presents significant fire and shock hazards.

## Electrical: Outlet Cover Missing, Undersized Conductor

Correct routing / protection of exposed cable: \$200–\$600.

Rewire dryer circuit with properly sized conductors (if required): \$800–\$2,000.

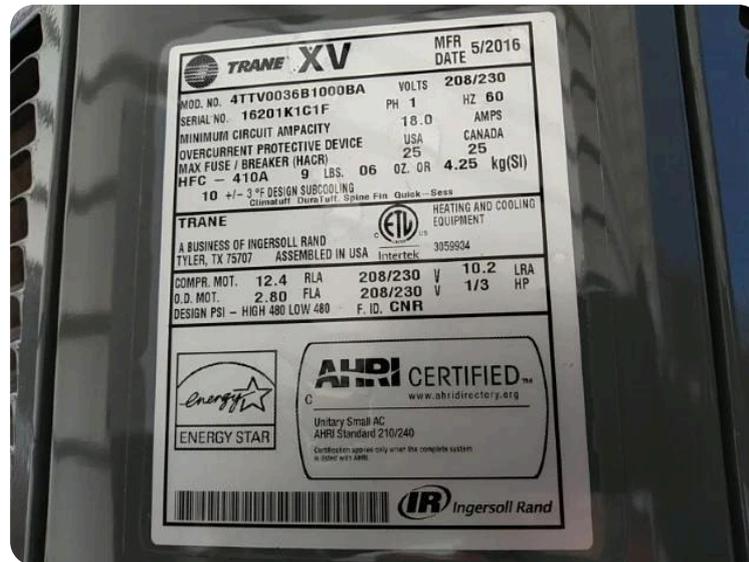
## Exterior: Unclear Presence of Electrical Disconnect for Condenser Unit

Have a licensed electrician verify the presence of an electrical disconnect for the condenser unit. Install an electrical disconnect if absent to meet safety standards and facilitate safe maintenance operations.
